ORNL-TM-627

REPORT ON FUEL-PLATE MELTING

AT THE OAK RIDGE RESEARCH REACTOR JULY 1, 1963

T. M. Sims
W. H. Tabor

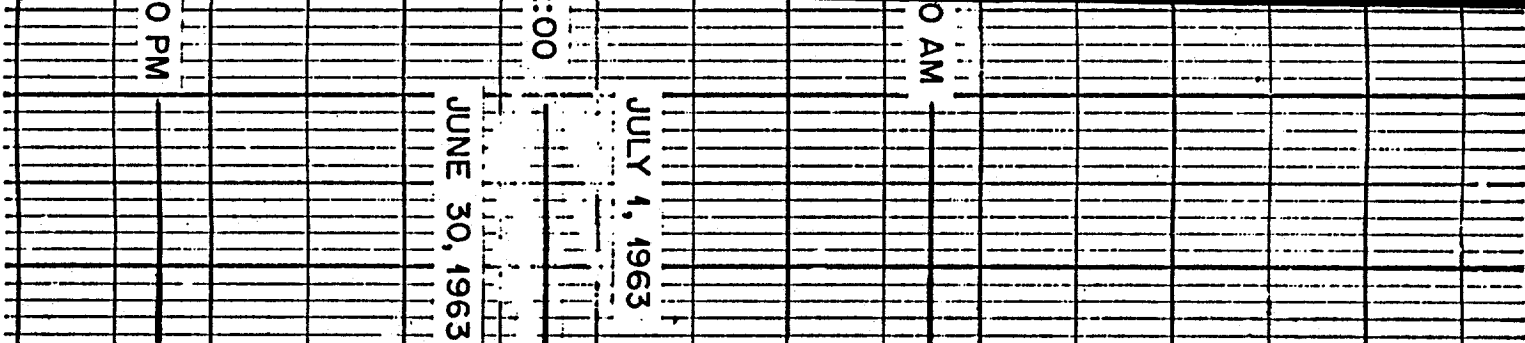
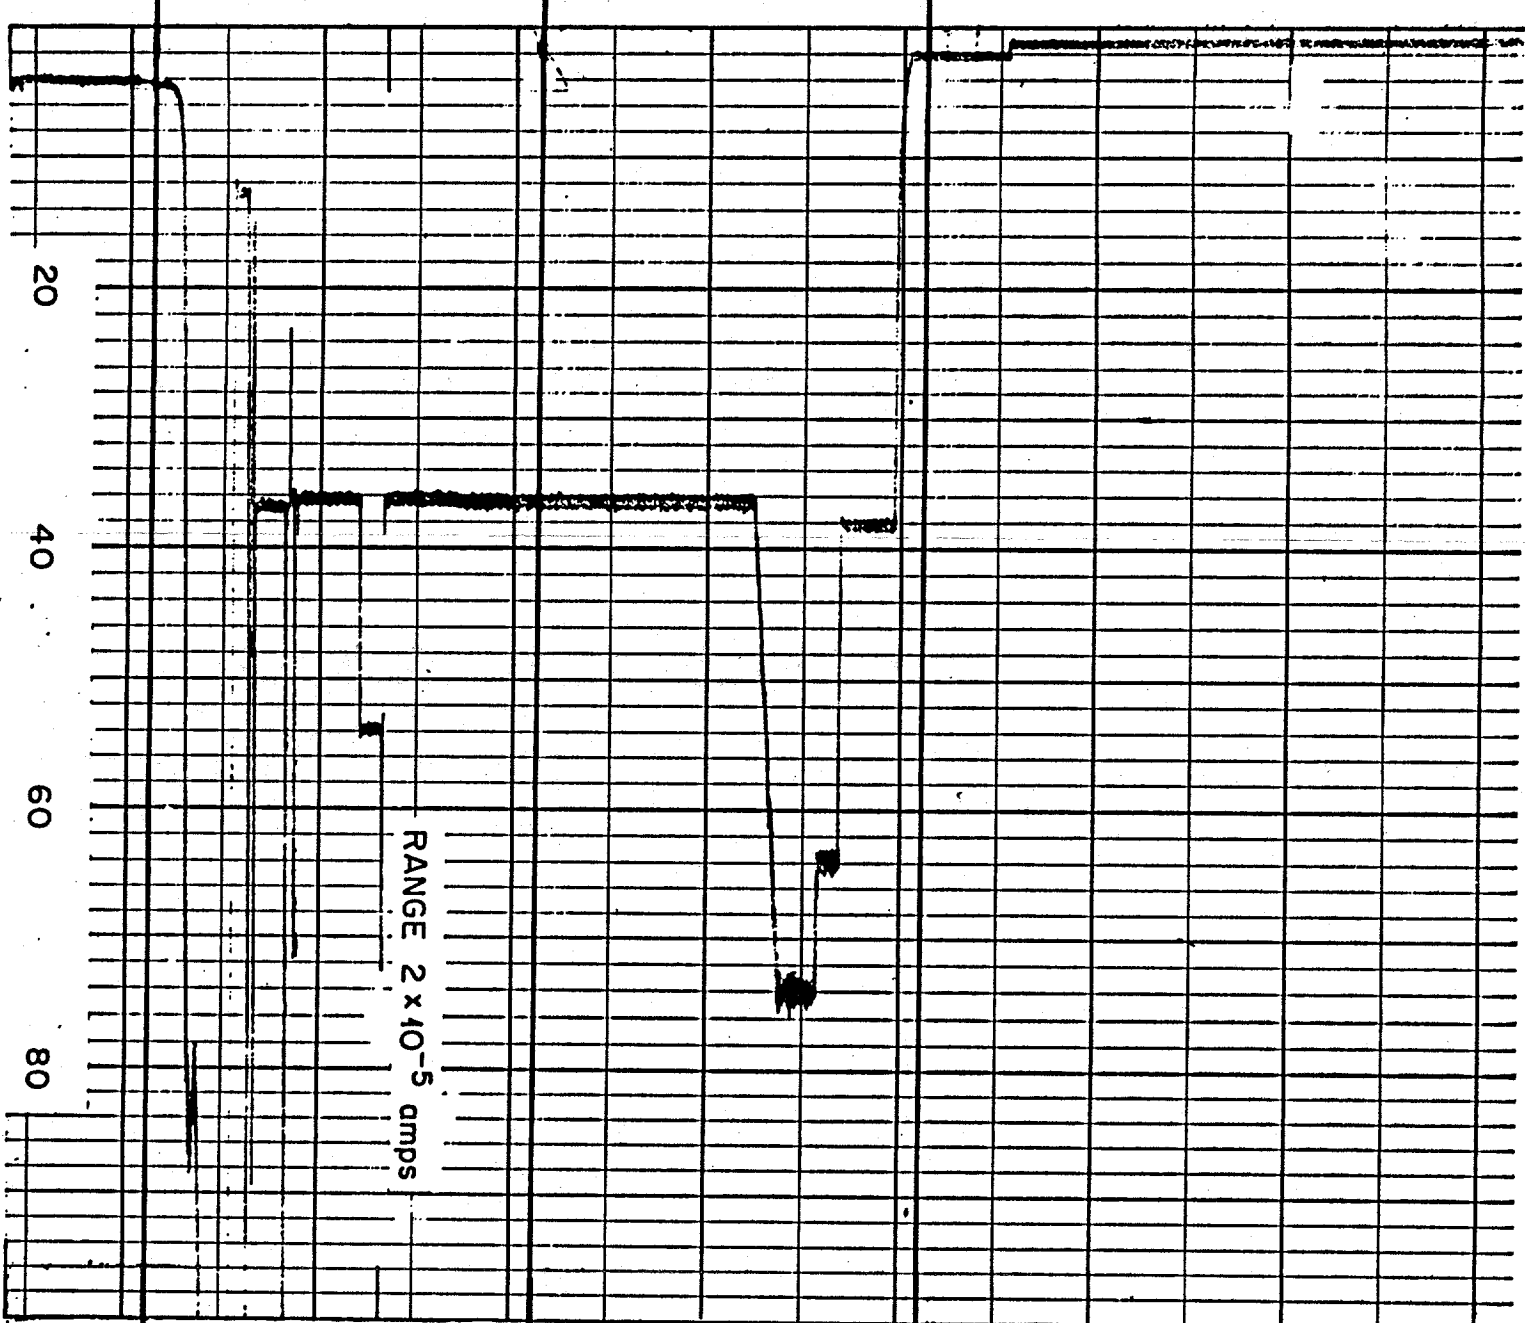
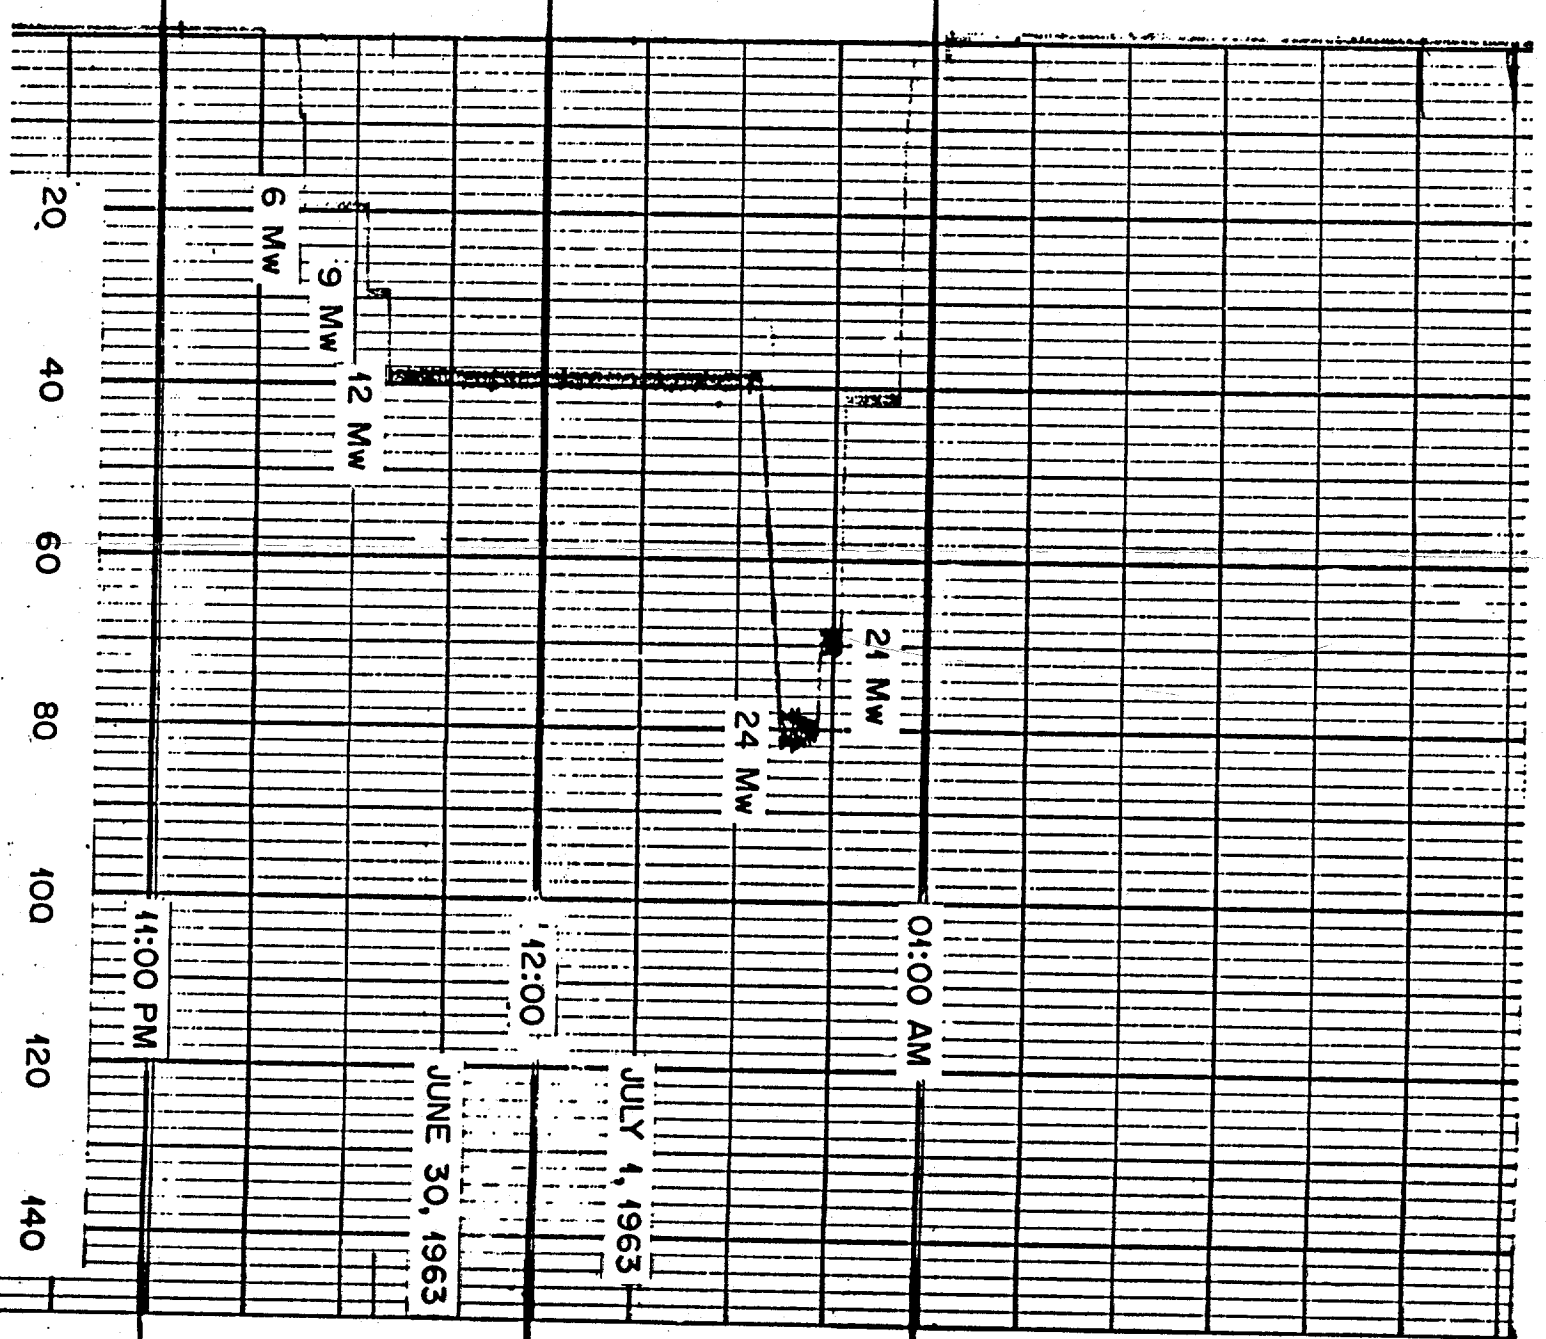
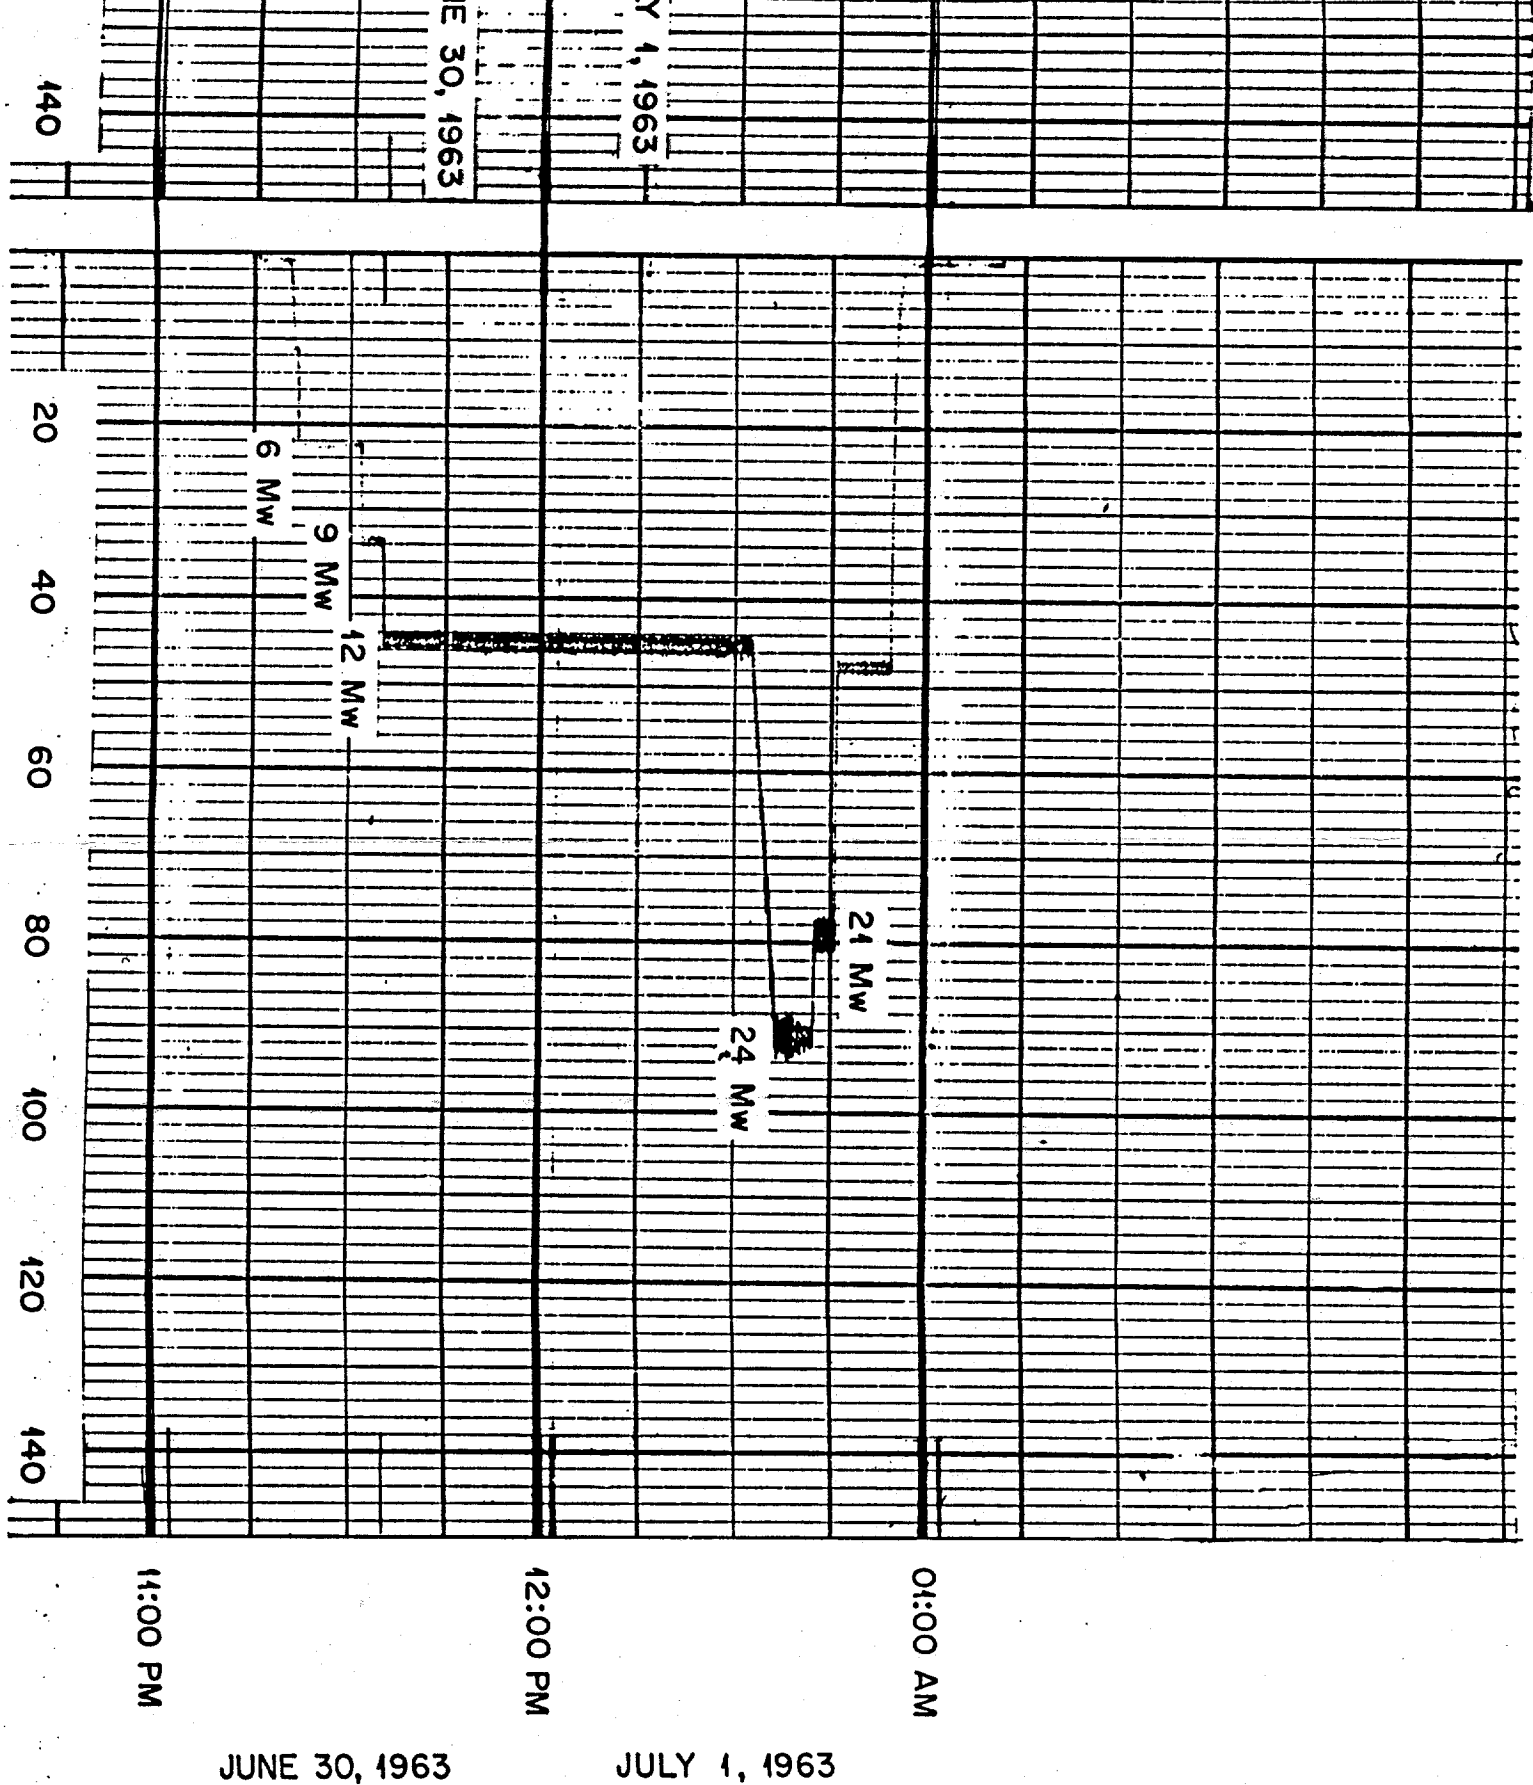
Fig. 1. Nuclear Instruments Recorder Charts from 10:30 PM, June 30, 1963, to 02:30 AM, July 1, 1963

Figures 1 and 2 display the recorder charts from the main control and safety instruments. These records were synchronized to facilitate their interpretation. For comparison, two recorder charts from a previous cycle (assumed to be normal) are also shown.

The reactor shim-rods withdrawal was started at 10:35 PM, June 30, 1963. The source level can be observed at the bottom of the No. 1 count-rate-meter chart. The log-N records indicate that the reactor power was stabilized for a few minutes at various levels: 4.4 kw, 330 kw (N_L), and 3, 6, 9, 12, and 24 Mw.

At the 9-Mw step, everything seemed normal although postincident examination of the log-N period and safety channel charts indicates a slight increase of the reactor noise. This observation is interesting because, if one assumes that the blocked element started to boil at about 9 Mw, it indicates that it took an increase of a factor of 2.7 in power to damage the element. Accounting for possible variations in coolant flow, this corresponds quite well with heat-transfer predictions.

It is worth noticing that the noise amplitude at 24 Mw, as shown by the two safety channel and the gamma chamber charts, remained constant during the first three minutes of the run and then decreased steadily. The various radioactivity monitors (see Figure 4) also indicate that the activity was released during the first two or three minutes of the 24-Mw run. Subsequent inspection of the fuel plates of the damaged element showed that only one plate melted, and it is possible that this occurred in a short time following which the melting stopped and the boiling which caused noise in the instruments became less severe.
